UNEARTHING FANNIE BAY GAOL: ARCHIVES AND THE ARCHAEOLOGY OF WATER MANAGEMENT IN DARWIN'S FIRST PURPOSE-BUILT PRISON

CLAYTON FREDERICKSEN

Northern Territory University, Darwin NT 0909, AUSTRALIA

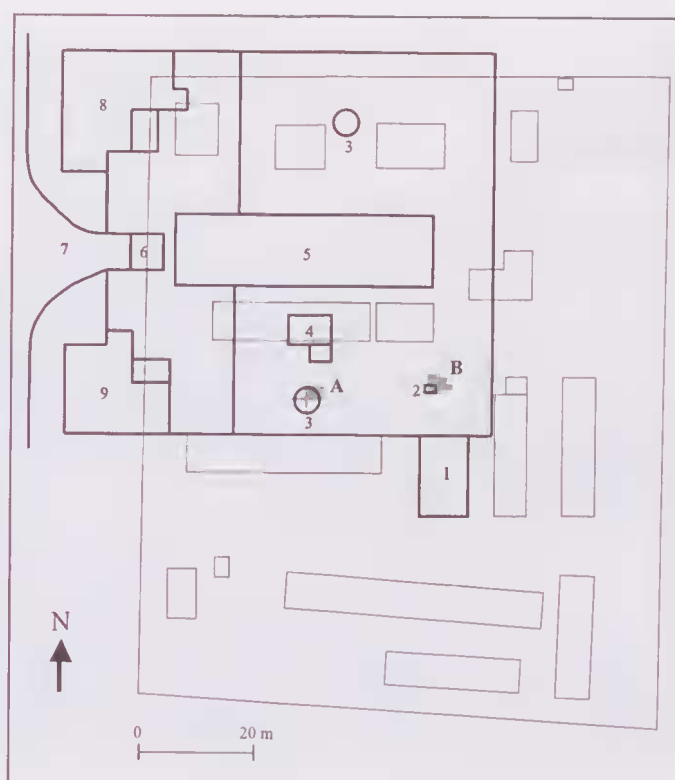
Fig. 2. Plan of Fannie Bay Gaol, with 1880s structures superimposed in heavy outline. The location of Excavation Areas A and B is shown. Key to numbers; 1 = infirmary, 2 = location of well, from historical sources, 3 = underground water tanks, 4 = kitchen, 5 = cellblock, 6 = watchtower, 7 = entrance, 8 = gaoler's residence, 9 = guards' barracks (Adapted from Troppo Architects 1996, with modification).

on information contained in the report. The 1883 Gaol had three main buildings – a stone cellblock (which still exists today) and separate Gaoler's and Guards' quarters, constructed at either corner of the western perimeter fence (Fig. 2). A watchtower was built a little later, probably 1887 (Dewar in press), and a kitchen possibly later still, perhaps near the turn of the century (Troppo Architects 1996). In 1887 an infirmary was erected outside the southern fence of the Gaol. This building was constructed of roughly dressed blocks of porcellanite which were probably quarried from Doctors Gully, a few kilometres from the Gaol (National Trust 1981). The infirmary remains standing today. The Gaol was initially enclosed by a 3.6 m (12 foot) high perimeter fence made of timber and iron (Troppo Architects 1996). The maintenance of the fence was a source of constant concern to the authorities throughout the early history of the Gaol. The ravages of tropical climate and termites rendered the fence ineffective after only a few years of its construction and repairs required continual attention. Escapes were numerous and this, along with a seemingly relaxed attitude toward security, gave the Gaol in the nineteenth and early twentieth centuries an undeserved reputation as a lax institution. In fact, as Dewar (1997a) recounts, conditions were harsh, characterised by unsatisfactory and frequently overcrowded living conditions, floggings, and a daily routine of hard labour on a variety of government projects outside the Gaol.

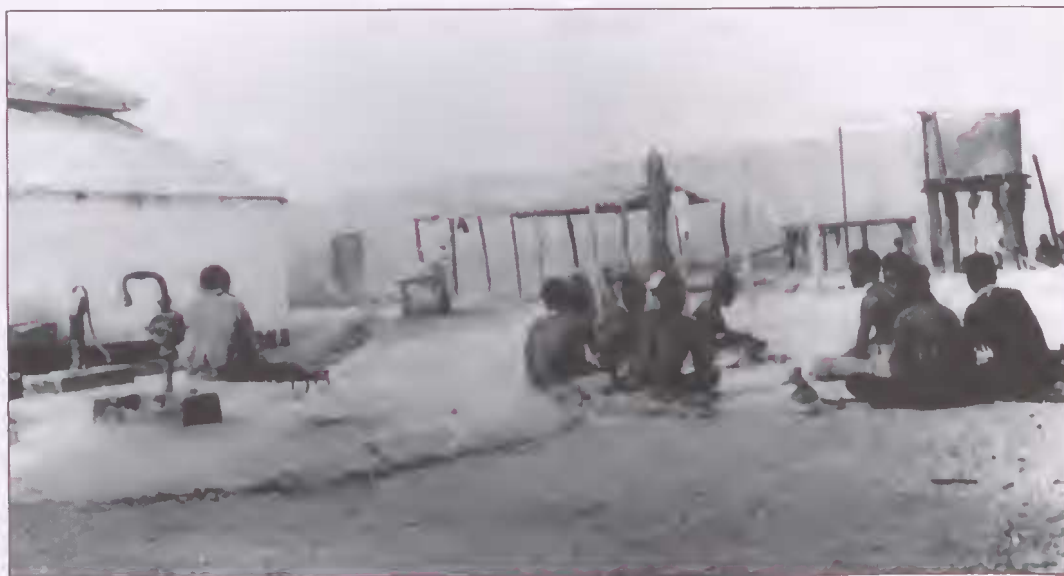
Fig. 3. Photograph of subterranean tank in Area A, looking toward eastern perimeter fence. Note concrete lid, pumps, drainage channel and washstand and tub (in background). Photograph of unknown date but almost certainly within the period 1910-1930s. (Photo: Museum and Art Gallery of the Northern Territory).

nevertheless repaired and used into relatively recent times. A photograph taken of the Area A tank sometime in the early decades of the twentieth century depicts a concrete lid with attached force pump (Fig. 3). The lid and pump are also visible in a 1930s oblique aerial photograph, in which the tank is clearly shown in the corner of the prison complex (Fig. 4). Both subterranean tanks may have been filled in sometime between 1955 and 1960 (Troppo Architects 1996). Certainly they were completely infilled by the mid 1960s (Troppo Architects 1996). It is possible however that infilling postdated the time the tanks ceased to be used for water storage.

Excavation. Two 50 cm wide trenches were laid out to form a 'cross' across the depression which marked the tank's location. Removal of the layer of turf exposed the concrete edging of the rim of the tank. This was of a standardised 18 cm thickness (Fig. 5). Excavation of the northeast quadrant of the 'cross' exposed a concrete drainage channel, which in Figures 3 and 4 is evident as having extended from the tank out toward the eastern perimeter fence. The mouth of the drain was formed by cementing clay bricks to form a 28 cm wide channel. This fed into the drain itself, which was 40 cm wide at the base and 90-130 cm wide at the top. The drain was constructed of roughly poured concrete and formed a feature approximately 20 cm deep. It was clear from their downward slope that the channel and drain were intended to direct water from, not into, the tank. The drain may have served to direct water out of the tank for washing, perhaps laundry, purposes. What appear to be a washstand and tub are illustrated adjacent to the drain in Figure 3.

of the location of the well. In both Figures 3 and 4 a pipe can be discerned protruding from the side of the water tank and then turning to extend vertically down to ground level, presumably into an underground cistern or well. When combined with the negative evidence from the Area B excavation, this provides a clue as to the possible location of the well. If the Gaol's first well is at the point where the tank pipe entered the ground, then it is situated only a few metres north of the excavation, probably beneath a present-day concrete path. Further archaeological investigation will be required to determine if this is indeed the case.

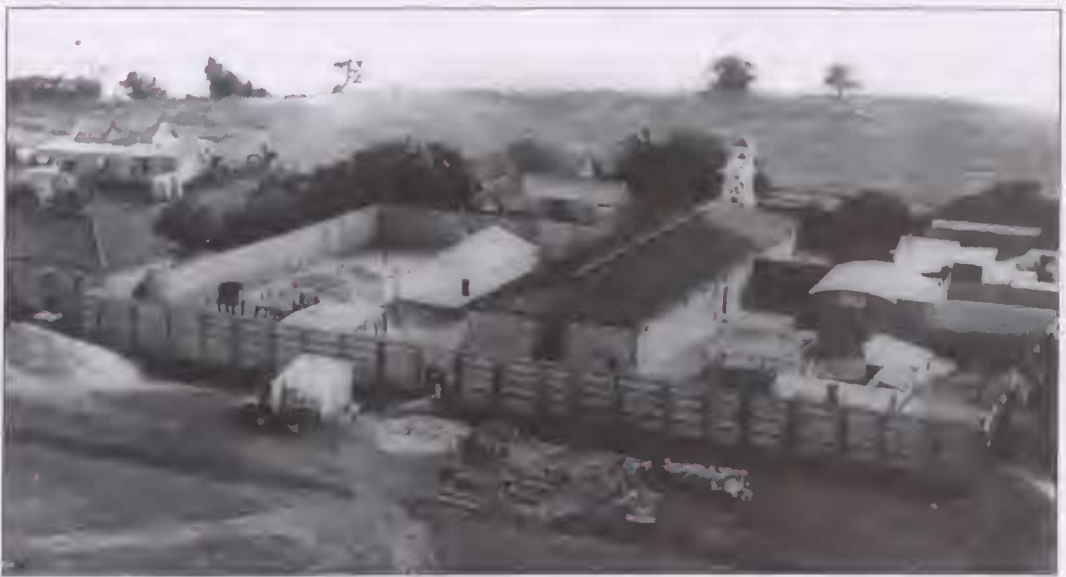
Fig. 4. 1930s aerial photograph of the Gaol. Area A tank is visible beyond the white kitchen building, in the top left (southwest) corner of the area enclosed by the perimeter fence. Note also the above-ground water tank on a stand in the lower left (southeast) corner of the Gaol, in front of the infirmary. (Photo: Museum and Art Gallery of the Northern Territory).

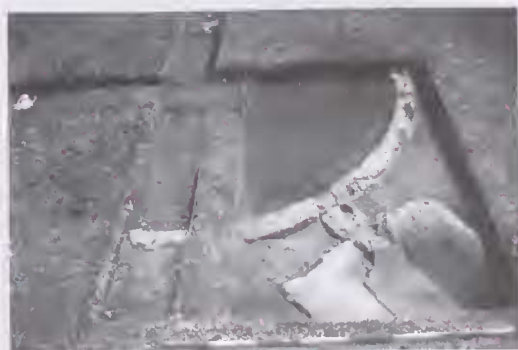
Fig. 5. Photograph of Area A depicting edge of water tank, and concrete drainage channel (in foreground).

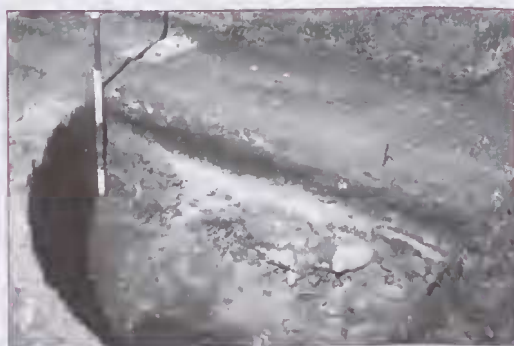
Fig. 6. Photograph of stratified fill uncovered inside the Area A water tank.

been used to infill the tank (Fig. 6). This was initially undertaken in 10 cm deep spits, later increased to 20 cm spits. Six different layers were exposed beneath the turf (Fig. 7). The uppermost was a widespread layer of mixed dark brown soil with small porcellanite nodules throughout (Layer 1). Immediately beneath the topsoil was a grey to black fine-textured soil (Layer 2). A charcoal lens was present within this layer. At the western end of the section was an intrusive layer of dark brown to grey soil (Layer 3), the lower part of which was differentiated by the presence of small stones. Beneath this layer were two layers of beach sand. One, restricted to the eastern part of the section and abutting the tank wall, consisted of light brown coarse sand (Layer 4). More extensive was a layer of very fine white beach sand (Layer 5), which partially overlaid Layer 4. Layer 5 was distinguished by the presence of a vertical feature, tapering from 25 cm to 10 cm and extending to the base of the excavation. This may have represented a posthole or similar depression. The sand of Layer 5 had evidently been poured into the abandoned tank and in so doing had infilled this depression or hole. The depression had been dug into the underlying layer (Layer 6), which consisted of dark brown soil with loosely placed porcellanite pieces. Layer 6 was similar in colour and texture to the Layer 1 topsoil and was probably redeposited topsoil mixed with pieces of extracted basement porcellanite.

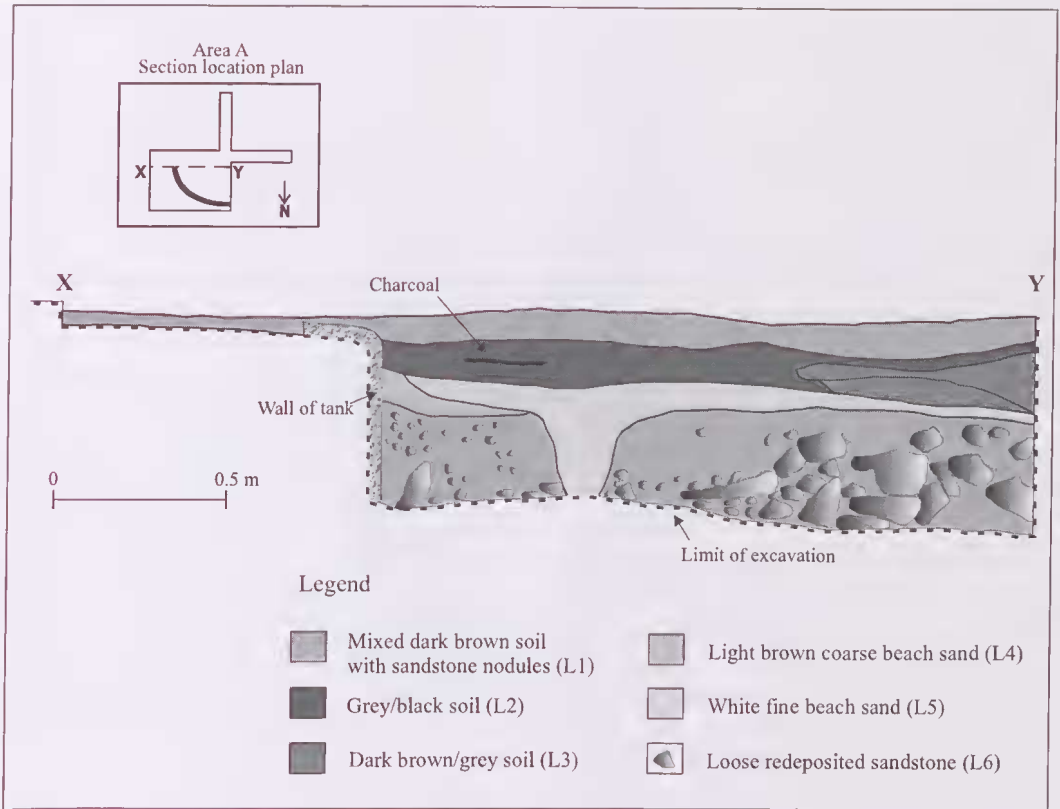
Fig. 7. Area A section depicting stratigraphy of fill inside the water tank.
